# SURVEY REPORT TABLE OF CONTENTS

**Report file no:** CWS-2012-13.  
**Inspection date(s):** July 9, 2012.  
**Date of written report:** July 10, 2012.  
**Disclaimer:** *The services rendered herein and the report furnished herewith are done with the specific understanding that the undersigned and or Wilson & Associates, LLC will not be held responsible under any and all circumstances for any and all errors, omissions, or failure to properly perform the requested services as set forth above. As it concerns the vessel described herein, all matters and statements contained herewith constitute statements of opinion only and not to be construed as representations, warranties, or guarantees and that, any and all statements made herein or in connection herewith will not be used for the basis of any claim, demand, or action against the undersigned. The request for services and the report herewith shall be construed to be an acceptance of the above conditions. Any and all claims for damages of what-so-ever nature asserted against the undersigned are limited to refund of the entire cost of the survey.*

**Vessel Yr/Make/Model:** 1970 Smedvik mek Versted.  
**Vessel name:** [REDACTED]  
**

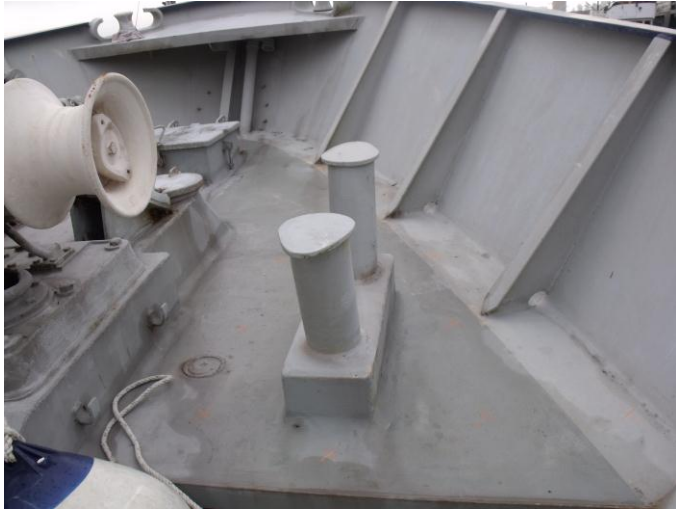
Fore deck area

The fore deck has had a fiberglass layer added. Present owner informed this surveyor that this had been done prior to the purchase of the vessel. Audio gauging is not possible through fiberglass. However, percussion testing of the entire main deck areas showed no signs of delamination of the fiberglass from the steel decking. Twelve (12) readings were taken from in the chain locker, essentially the under side of the fore deck. The average reading was 11.46mm. According to builder's plans the main deck is made of 7mm steel. Based on the TM-8811 reading approximately 3mm higher on the sample plate provided these readings would be consistent for a 7mm steel deck with a 1-2mm coating of marine paint. This would mean the fiberglass layer may have been added as a protective measure rather than a corrective one due to excessive corrosion.

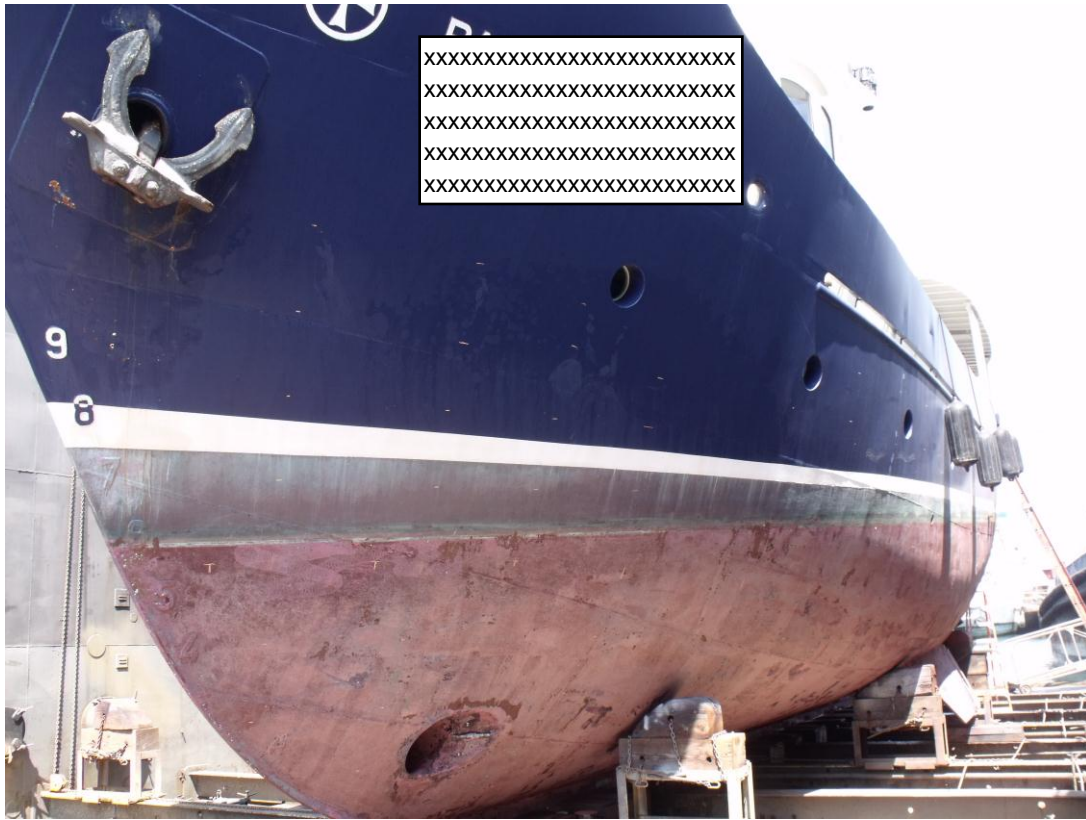
This photo shows the chalk grid markings for taking the audio gauge readings.

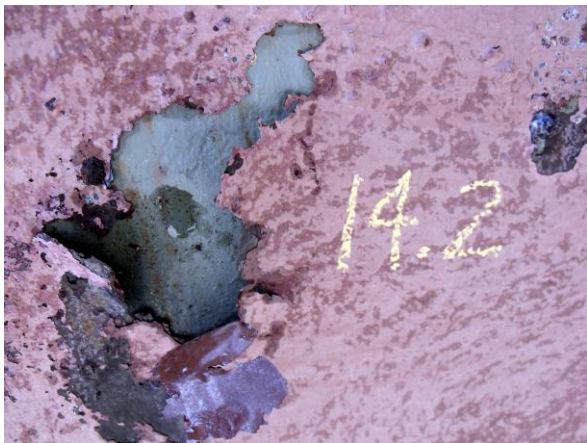
**Bottom paint:** [Anti-fouling bottom paint in need of renewal. RECOMMENDATION: Remove all loose flaking paint, prep and repaint entire bottom with fresh bottom paint before next launch.](#)

Example of the peeling bottom paint.

There was also a white milky fluid inside, indication the paint had not cured properly. Note the thickness reading, which is close to bare metal, but not quite.

Anti-fouling bottom paint in need of renewal. **RECOMMENDATION:** Remove all loose flaking paint, prep and repaint entire bottom with fresh bottom paint before next launch.

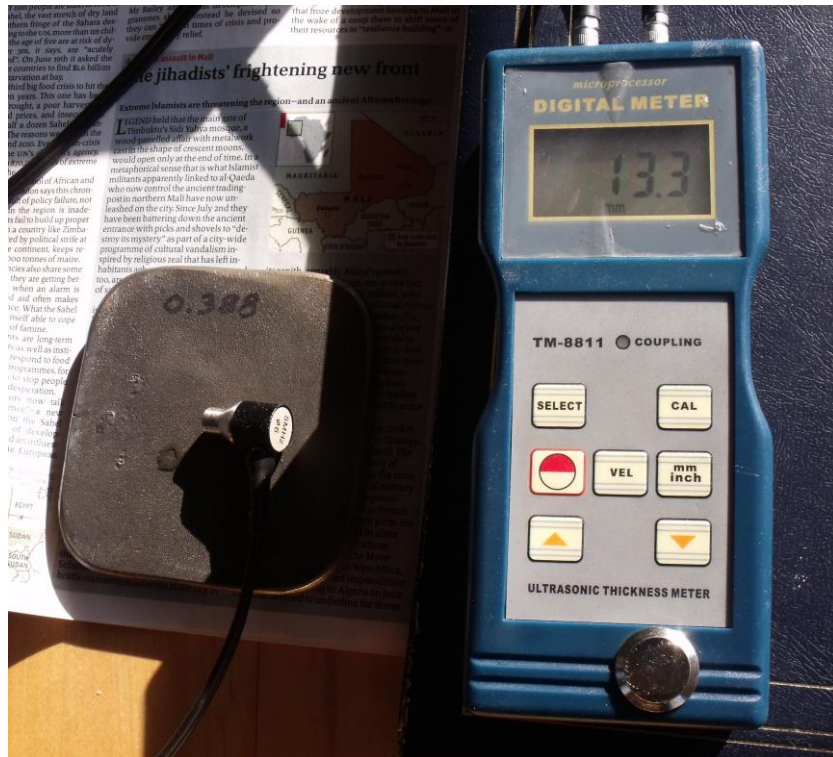
In preparation a single (1) CE certified TM-8811 portable 5 mhz ultrasonic thickness measuring instrument (accuracy + 1.0%) was calibrated just prior to inspection on a known thickness plate of 5.0 mm or 0.197" (glycerin was used as a couplant). The UT gauge was regularly rechecked for proper calibration. The transducer was 10 mm in diameter, with velocity set for steel. UT unit 'A' was used. The vessel's owner was able to provide a piece of hull plate which had been removed for installation of the bow thruster. The TM-8811 read this sample plate at 13.3mm.

The TM-8811 meter used and the sample plate from the owner.
