**2010 Sea Ray Boats 450 Sundancer**

Charles W Solarek, AMS 1161, Y&SC

Inspected on June 06, 2022. Report written June 14, 2022

# Report of Marine Survey

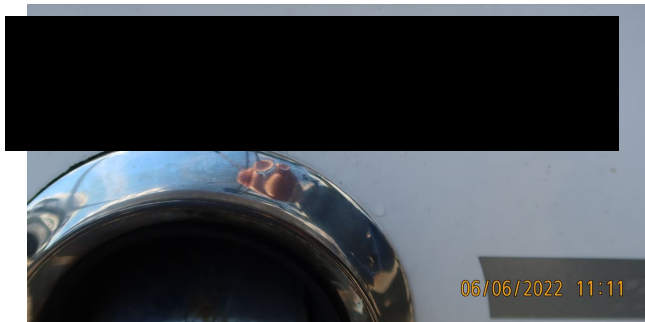
The vessel's HIN (Hull Identification Number) was verified during the survey inspection.  
The Hull Identification Number (HIN) is in agreement with the vessel's USCG on-line documentation.  
A true digital photograph of the HIN of the referenced vessel is shown here.

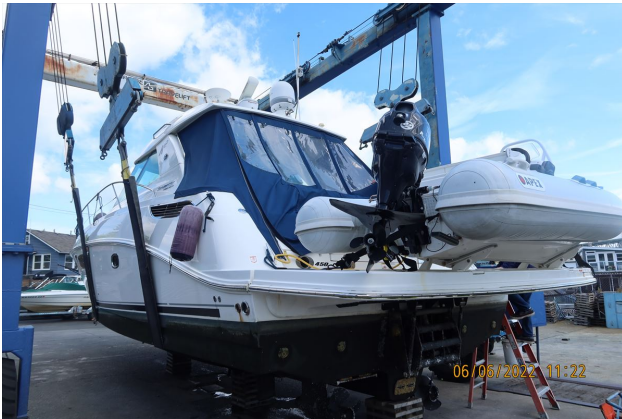
## SWIM PLATFORM

Electro-hydraulic swim platform/tender lift with dinghy chocks. Demonstrated.

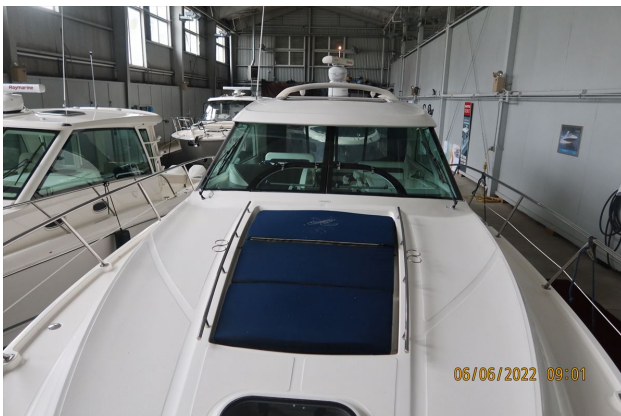
Good condition. Deck is solid under foot, no soft spots discovered, and no visible cracks or chips sighted.

Random percussion hammer testing on horizontal deck surface showed no evidence of any delamination.

All moisture meter readings on the fore decks were relatively dry with normal comparative moisture meter readings.

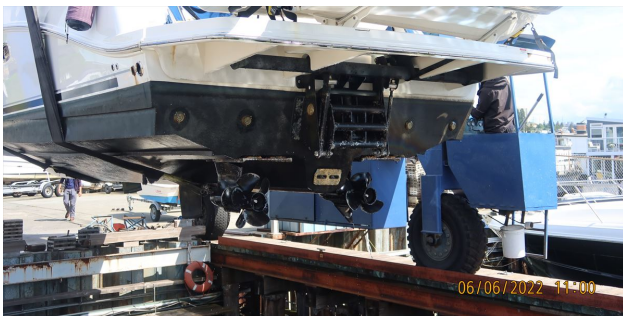
### DRIVES

Mercury Marine/Cummins Marine Zeus Pod Drives.

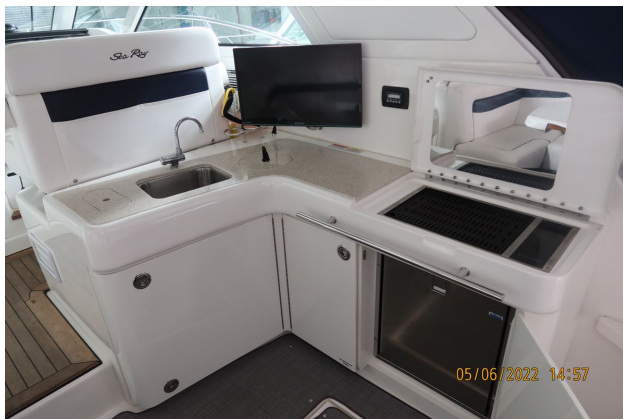
DC electric hatch for access to the engine compartment. Functional.

The cockpit included: (1) a wet-bar sink, cold water only. Sink was functional and no leaks sighted; (2) a DC powered U-Line Refrigerator/Freezer. Powered up in both AC and DC modes. Appeared to be functional. (3) an electric grill. Burner tested and was functional.

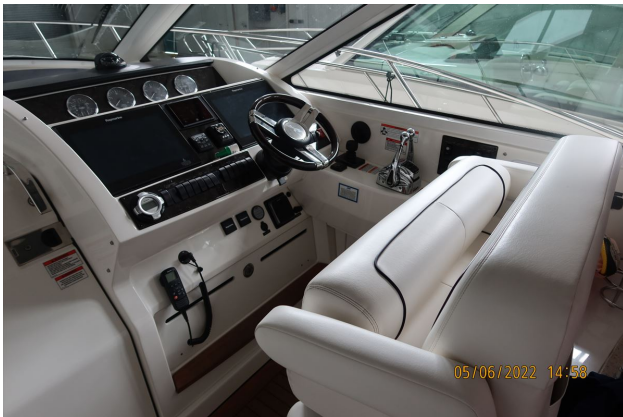
#### HELM STATION

Express bridge, starboard side.

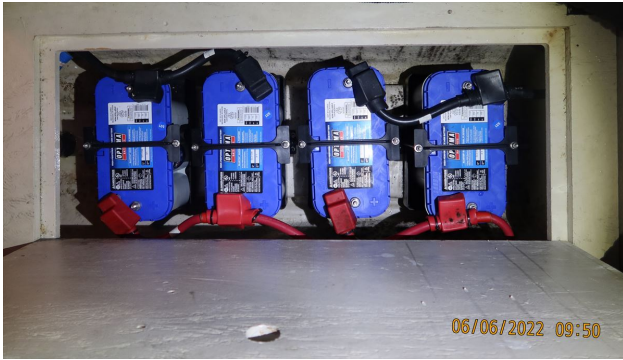
Four (4) Optima "Blue Top" 12-volt sealed AGM batteries in the engine compartment, centerline bilge area (5/21).

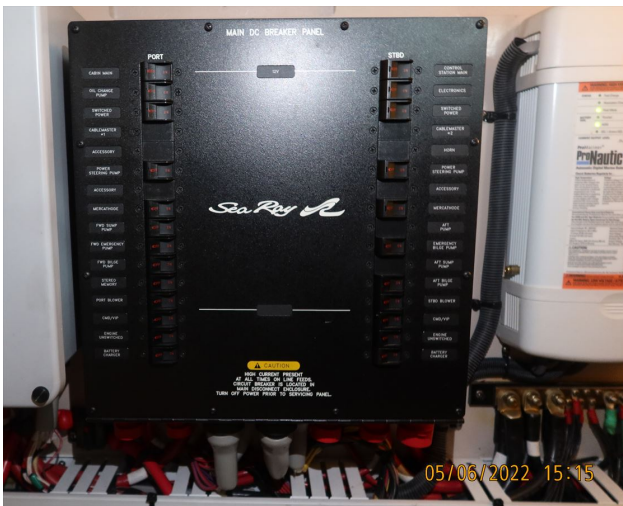
## DC PANLEBOARD

Yes, in the engine compartment.

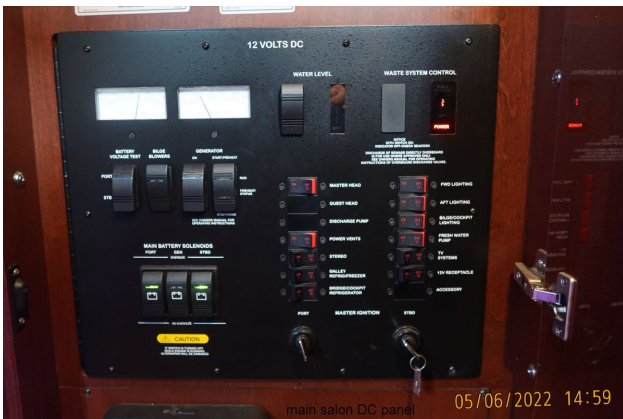
## SECONDARY PANEL

Yes, at the helm station and in the main salon.

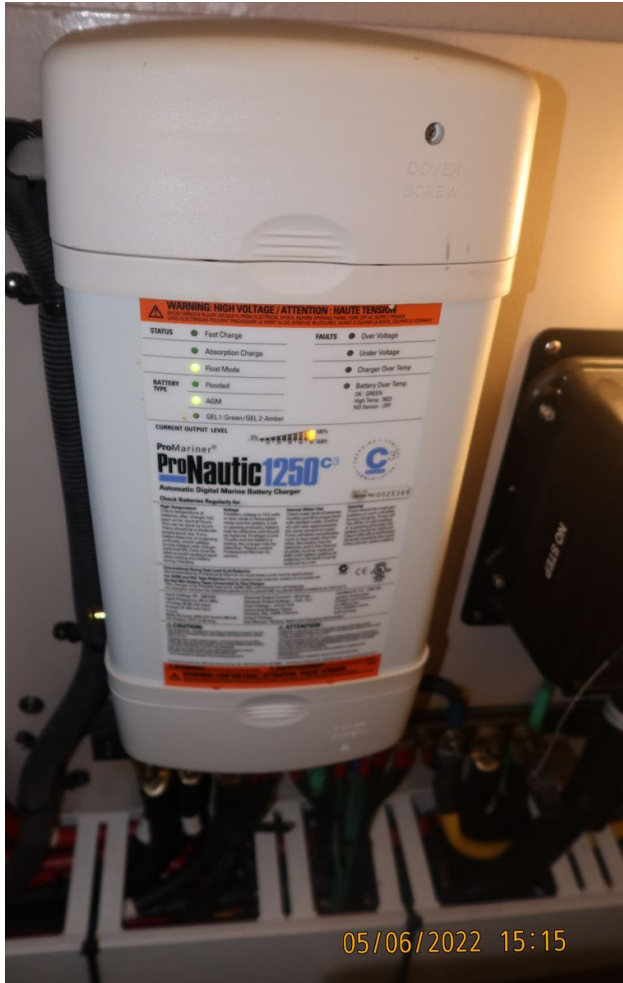
## BATTERY CHARGERS

ProMariner ProNautic 1250 c3 - 12 volt / 60 amp. battery charger. Appears to be functional.

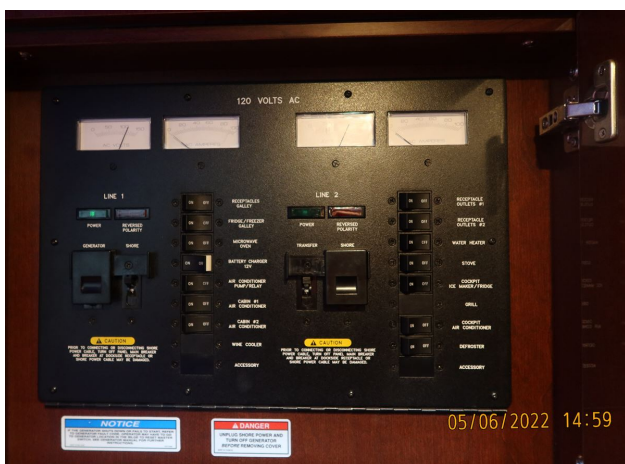
### AC PANELBOARD

Yes, in the main salon.

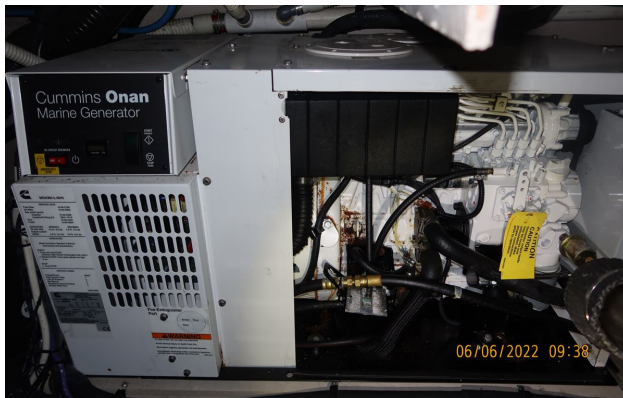
#### GENERATOR MODEL

Cummins 11.5MDK8M-1401E, serial number J090033838, installed in sound box.

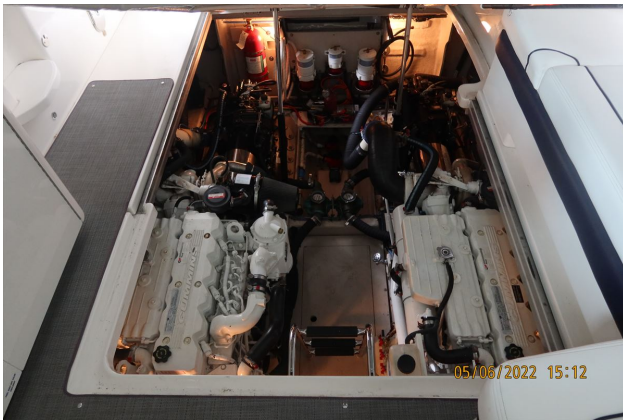
#### ENGINE MODEL

Twin, Cummins Marine QSB 480 HO P 5.9 Liter (359 CID), turbocharged & aftercooled with airseps.

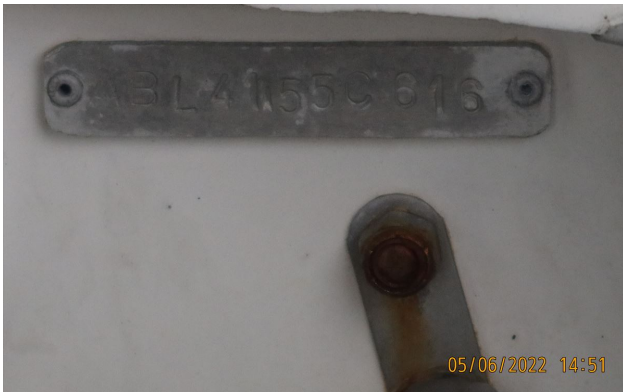
### HIN (HULL IDENTIFICATION NUMBER)

ABL4155C616

A true digital photograph of the hull ID number of the referenced vessel is shown here.
