**2010 Sea Ray Boats 450 Sundancer**

Charles W Solarek, AMS 1161, Y&SC

Inspected on June 06, 2022. Report written June 14, 2022

# Report of Marine Survey

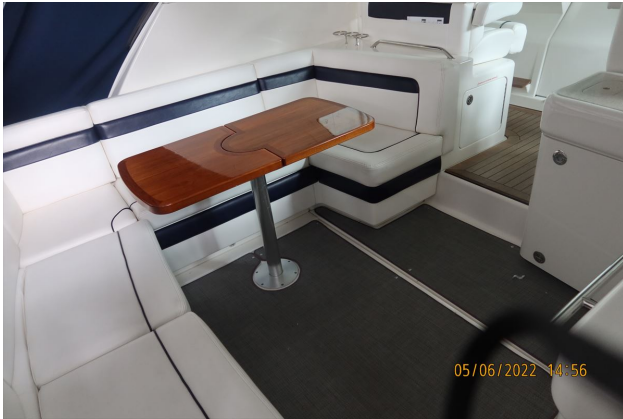
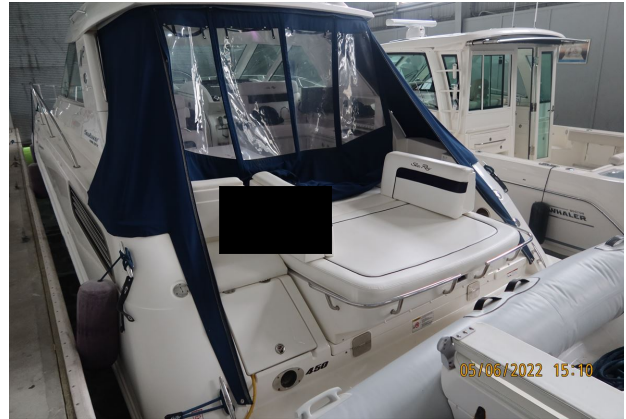
The vessel's exterior soft goods appeared serviceable with no significant wear or weathering.

No significant corrosion was observed on the vessel's hardware.

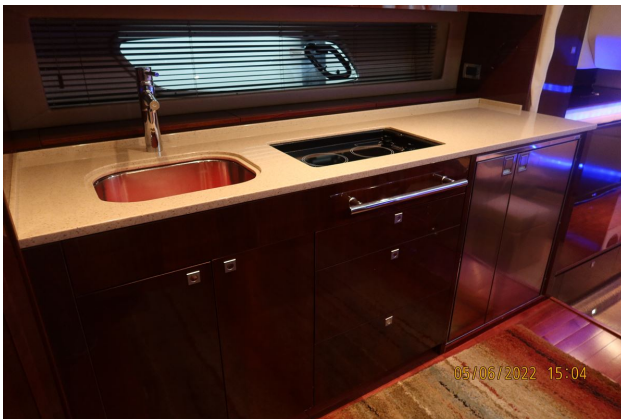
Isotherm by Indel Marine stainless-steel refrigerator/freezer, model 1200BB4YK0000, serial number 4160253. Refrigeration tested on both AC and DC circuits separately and powered up in both modes. Appeared to be functional.

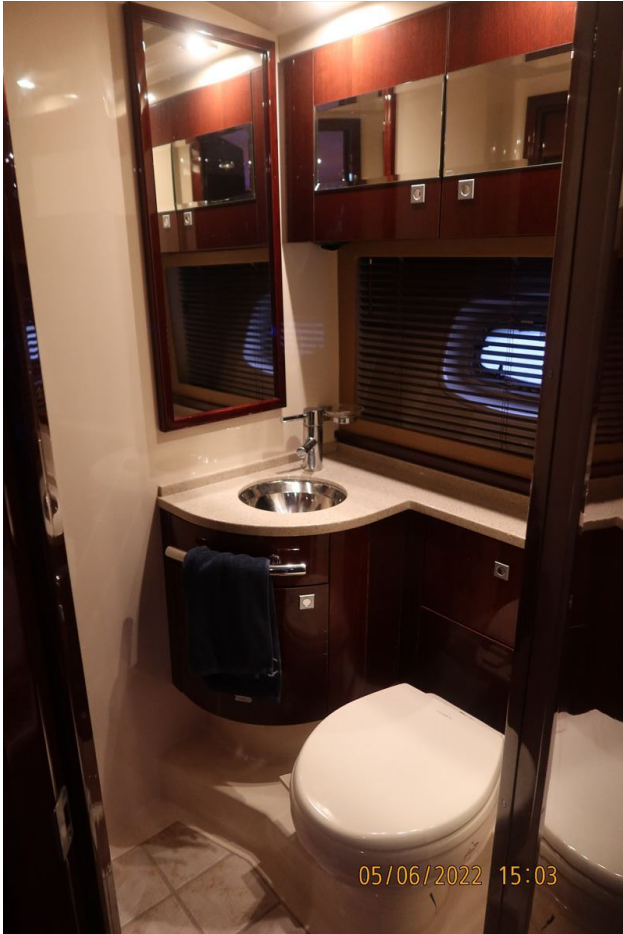
Stainless steel with "Corian" type counters. Hot and cold pressure water fixture at sink. No leaks sighted.
